PJ'S BASS LAKE DAM
ST FRANCOIS COUNTY, MISSOURI
MO 31189

PHASE 1 INSPECTION REPORT NATIONAL DAM SAFETY INSPECTION

JUNE 1981

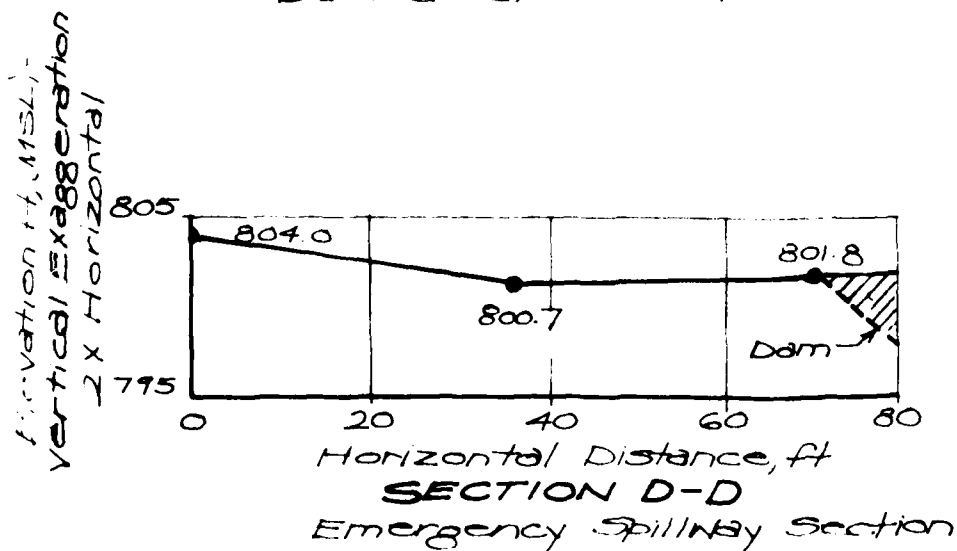
Fig. 3-A

The visual inspection indicated some settlement may have occurred leaving the center of the dam crest lower than the ends. The field survey (Fig. 3A) shows the center to be approximately 0.6 ft lower than the right end and more than 2 ft lower than the left end of the dam. The horizontal alignment of the crest does not appear disturbed, although this is difficult to assess due to the curving downstream configuration.

- a. Visual inspection. The visual inspection identified no signs of cracking, sinkhole development, or animal burrows on the embankment. The field survey noted minor settlement had occurred near the center of the embankment (Fig. 3A). Seepage was noted at the toe of the dam. This was reported by Mr Hunt as a spring which existed prior to the building of the dam. If this is the case, it does not appear that any special precaution was taken during construction to install a filter over the spring. Total seepage flow was estimated at 5 gal/min. The seepage water did not appear to be transporting any soil, and was not considered to pose a hazard to the stability of the dam at the time of the inspection.

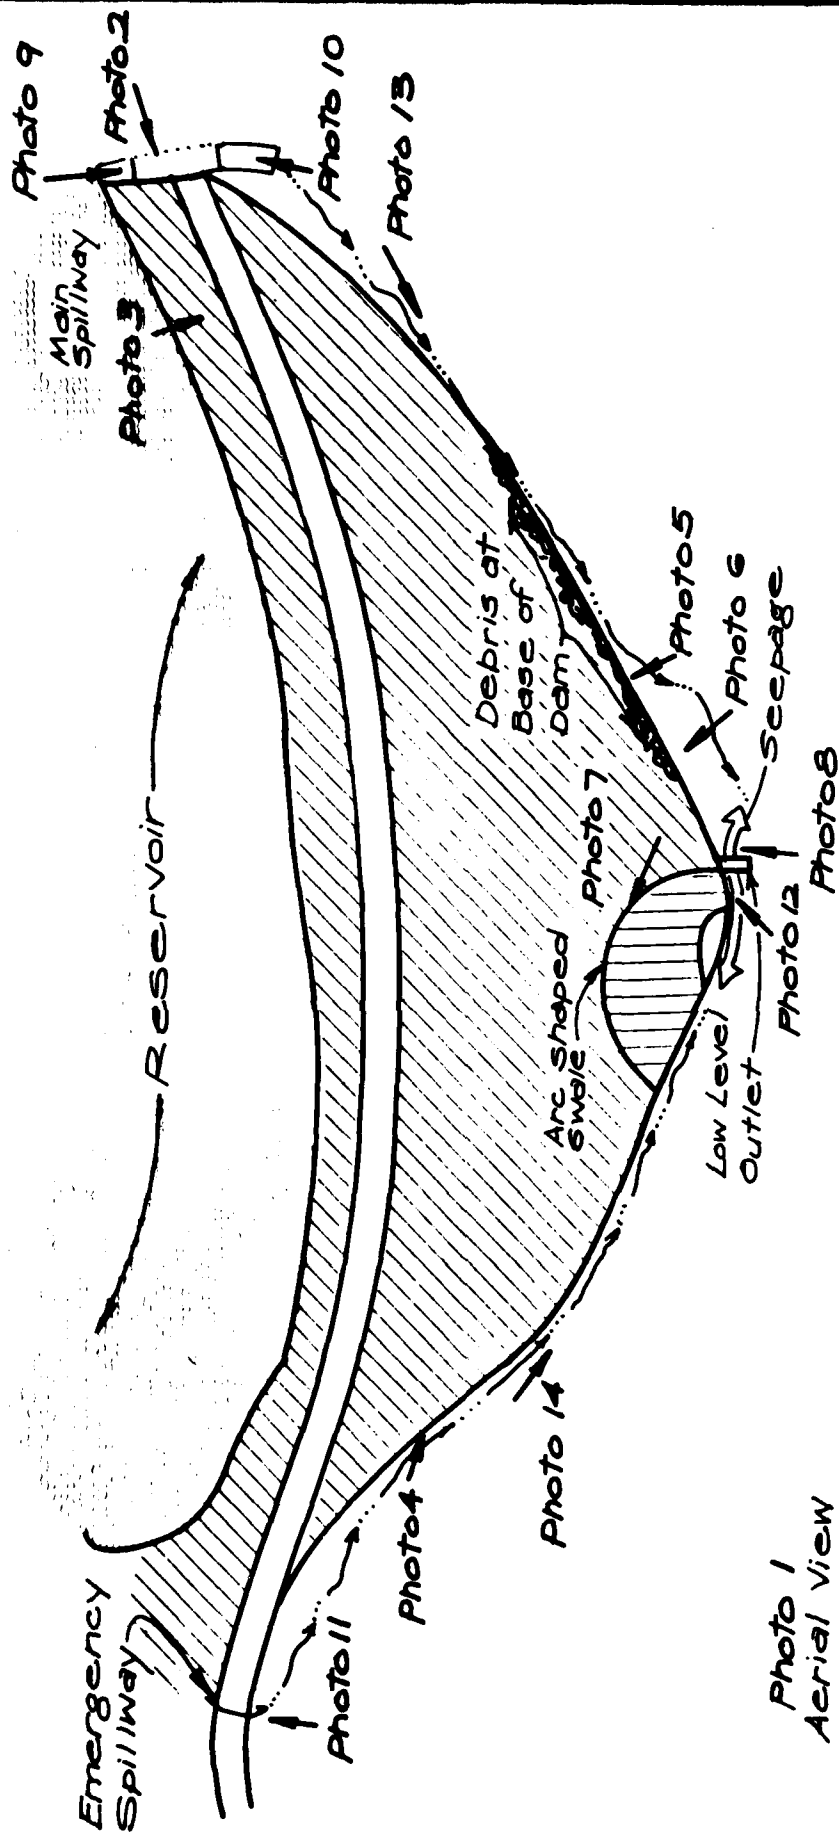
- d. **Hazard classification.** The St Louis District (SLD), Corps of Engineers, has classified this dam as having a high hazard potential; we concur with this classification. The SLD estimated damage zone length extends approximately 1 mile downstream to the flood plain of the Big River. Within this estimated damage zone are Missouri State Highway E, several occupied dwellings and assorted farm buildings. The contents of the damage zone were verified by aerial reconnaissance (Photo 1).

1. Typical contents of downstream damage zone. Dam is out of picture to the right.
